# Parallel Gelcoat Cracking in Boat Decks

[Campion Marine](#) is the last remaining open-mould glass fibre reinforced polymer (GFRP) manufacturer of luxury boats in Canada, and has been active for over 36 years. It has released numerous product lines, ranging from closed-deck speedboats to open-deck pontoons. Each product line is used in different outdoor environments and a variety of manufacturing practices have been adopted by Campion to produce high quality and robust products. One recurrent problem experienced by Campion is the cracking of the gelcoat on deck components, which are returned under warranty for repair. Each event can cost the company in excess of CAD\$1000 when they are repaired in the field. CRN has investigated the cause of this problem and has issued a set of recommendations to help prevent it.

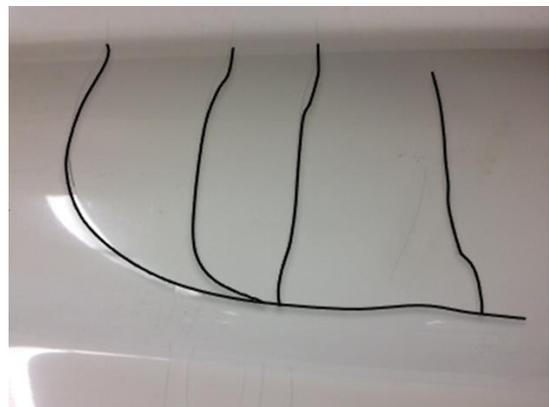
Highlighted zone of gelcoat cracking.

CRN researchers concluded that improper cure management primarily caused the cracks. Post-cure in the field, and during operation, likely caused dimensional changes that led to cracking. Images taken by the X-ray Micro-CT also revealed resin bloating around the cracks due to the ingress of moisture, which exacerbated the problem.

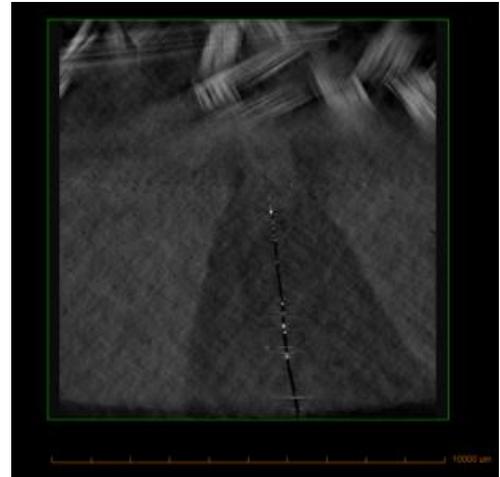
X-ray micro-CT of a sample of cracked gelcoat cut from a deck.
