Parallel Gelcoat Cracking in Boat Decks

Campion Marine

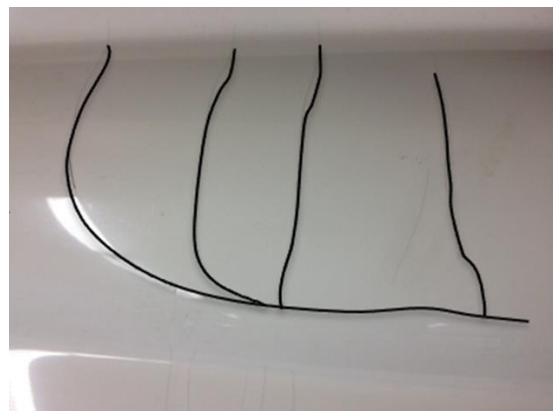
Despite being cosmetic in nature, gelcoat cracks leading to warranty repairs have extensive associated costs, often in the order of over CAD\$1000. Campion Marine did not understand the cause of the cracking.

Highlighted zone of gelcoat cracking.

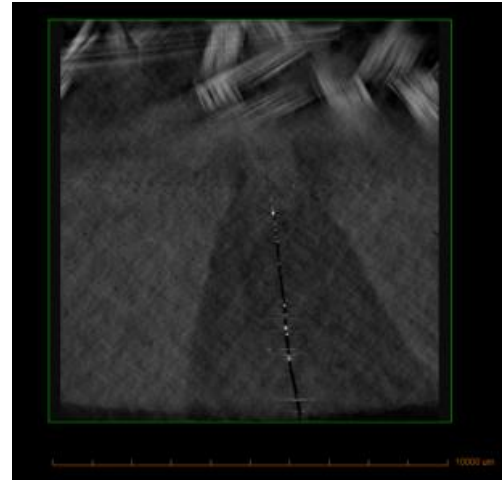
CRN researchers concluded that improper cure management primarily caused the cracks. Post-cure in the field, and during operation, likely caused dimensional changes that led to cracking. Images taken by the X-ray Micro-CT also revealed resin bloating around the cracks due to the ingress of moisture, which exacerbated the problem.

X-ray micro-CT of a sample of cracked gelcoat cut from a deck.
