De-moulding and Surface Quality

SUMMARY

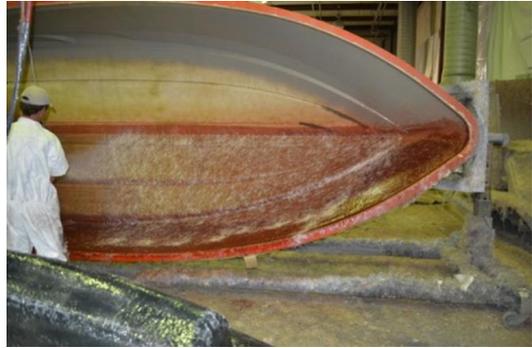
Bulk laminate is sprayed onto a boat hull and left to cure.

APPROACH

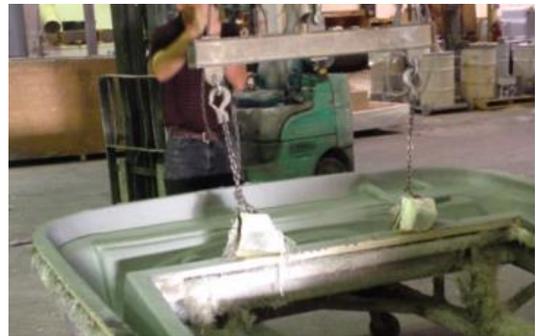
Boat deck being de-moulded after curing.

Engineers tracked the degradation of tooling for a boat hull and boat deck over the course of five manufacturing cycles of mould preparation, bulk laminate deposition and cure, as well as de-moulding. The results revealed a definite trend of increasing surface roughness in all three geometric regions measured (horizontal, sloped, and vertical surfaces). For the mould considered, and with the materials used, the rate of degradation for the moulds was approximately an increase of 6nm for R_a in each cycle.
