# Outdoor Storage of Glass Fibre Reinforced Polymer (GFRP) Moulds

## SUMMARY

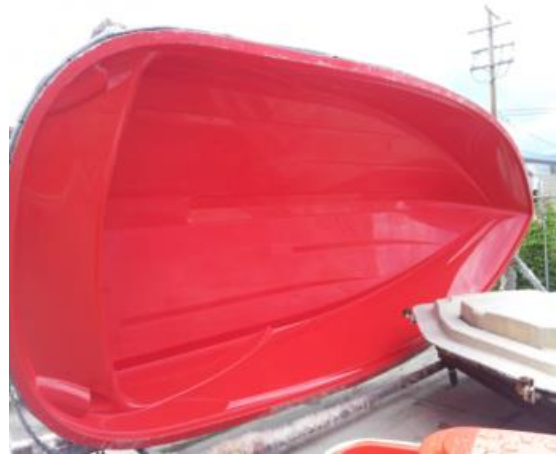
Boat hull mould stored outdoors.

Prior to this project, CRN researchers had already undertaken laboratory-scale experiments to clarify the mechanisms of mould degradation. CRN staff engaged directly in a production solution, monitoring the surface quality of a *Campion* specimen mould stored outdoors without protection over a ten-week period. From this study, rates of degradation were determined. Subsequently, a second phase of the project was initiated that compared typical indoor degradation data with surface quality data for another mould stored outdoors, but with a protective coating. The results allowed *Campion* to make better decisions, in terms of selecting storage methods based on costs, time and quality.

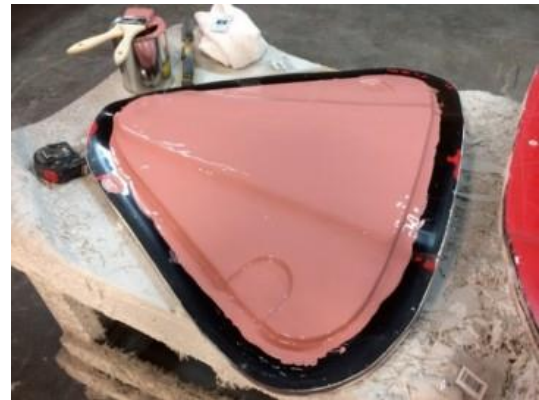
Mould with polymeric storage film brushed on prior to storage outdoors.
