Outdoor Storage of Glass Fibre Reinforced Polymer (GFRP) Moulds

SUMMARY

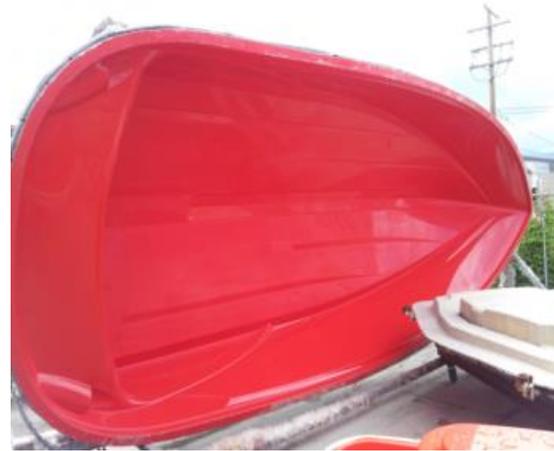
Boat hull mould stored outdoors.

Prior to this project, CRN researchers had already undertaken laboratory-scale experiments to clarify the mechanisms of mould degradation. CRN staff engaged directly in a production solution, monitoring the surface quality of a *Campion* specimen mould stored outdoors without protection over a ten-week period. From this study, rates of degradation were determined. Subsequently, a second phase of the project was initiated that compared typical indoor degradation data with surface quality data for another mould stored outdoors, but with a protective coating. The results allowed *Campion* to make better decisions, in terms of selecting storage methods based on costs, time and quality.

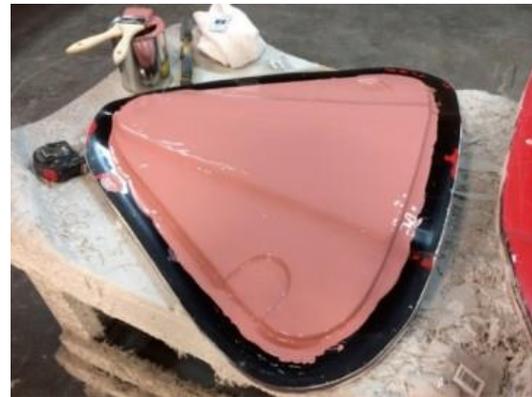
Mould with polymeric storage film brushed on prior to storage outdoors.
